(6) ION IMPLANTATION METALLURGY *

(10) C.R. Clayton, H. Herman, S.B. Agarwal, N. Avadhany
K. Doss, W.-W. Hu and S. Prasad

(9) Technical Report No. 1

The Office of Naval Research

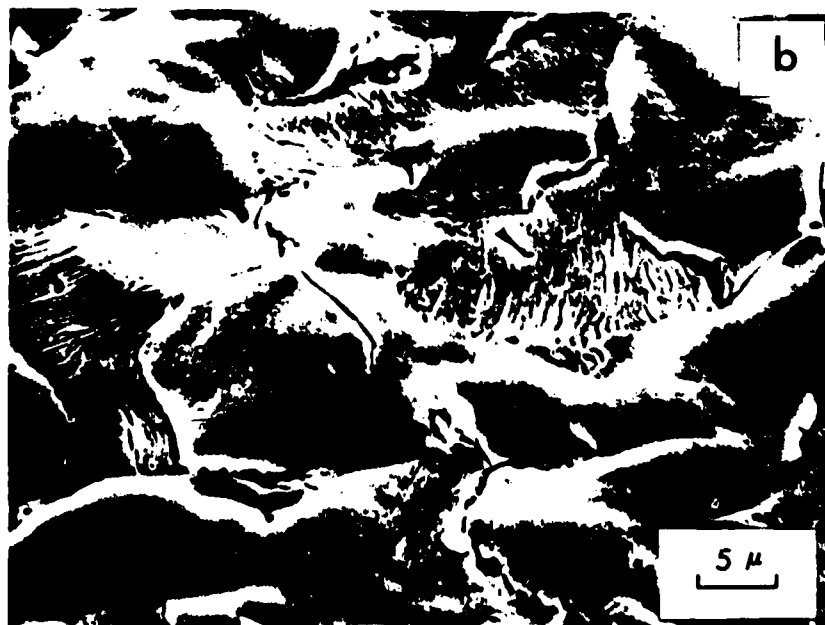
Fig. 3

After 45 minutes of exposure, the grain boundaries between the ferrite and pearlite were delineated in samples (2) and (3), Fig. 3(a), 3(b). Also, cracks formed along the grain boundary and propagated into the ferrite. The lamellar structure of pearlite can be clearly identified due to the delineation and microcracking develops between the cementite and ferrite. Relative to samples (2) and (3), the former has a rougher surface, which can be seen at higher magnification, as illustrated in Fig. 4(a), (b). As for sample (1), neither the grain boundary nor the pearlite structure is visible, Fig. 2. The entire surface is rougher than sample (2) and (3). However, cracking is not visible.

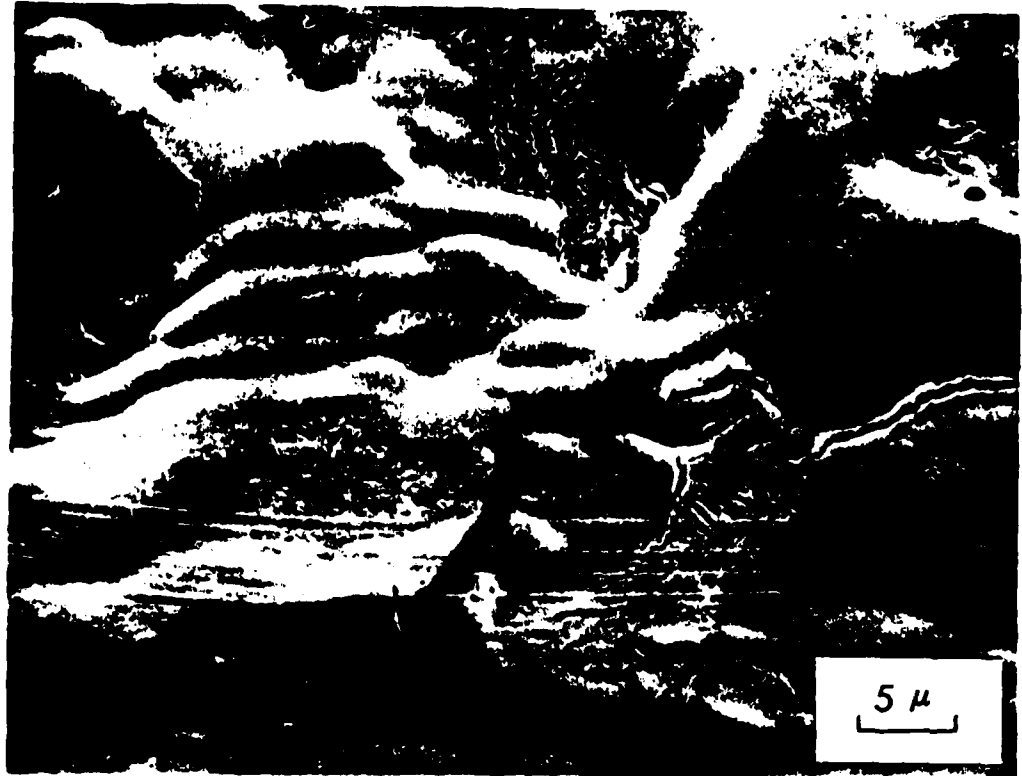
Fig. 7

- Fig.7 Initiation and propagation of cracks in the following implantation and aging sample after exposure to cavitation for 28 minutes.

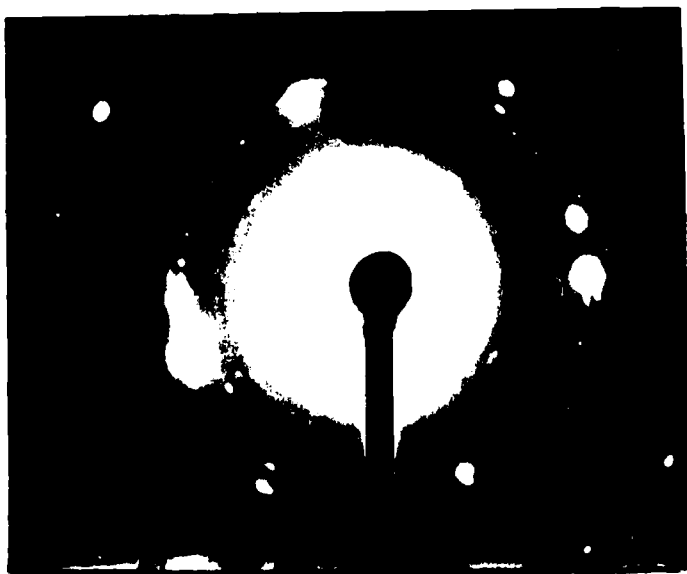
- Fig. 1a Bright field micrograph of Be implanted Cu
- Fig. 1b Electron Diffraction pattern for the above
- Fig. 1c Dark field micrograph of CuBe precipitates
- Fig. 2a Bright field micrograph of As implanted Au
- Fig. 2b Electron Diffraction pattern at room temperature
- Fig. 2c Electron Diffraction pattern at 460°C
- Fig. 2d Electron Diffraction pattern at 555°C
- Fig. 2e Electron Diffraction pattern at 790°C
- Fig. 2f Bright field micrograph of As implanted Au at 790°C
